Revitalising The Railway: A Case Study on the Refurbishment and Transformation of Life Expired Lineside Buildings

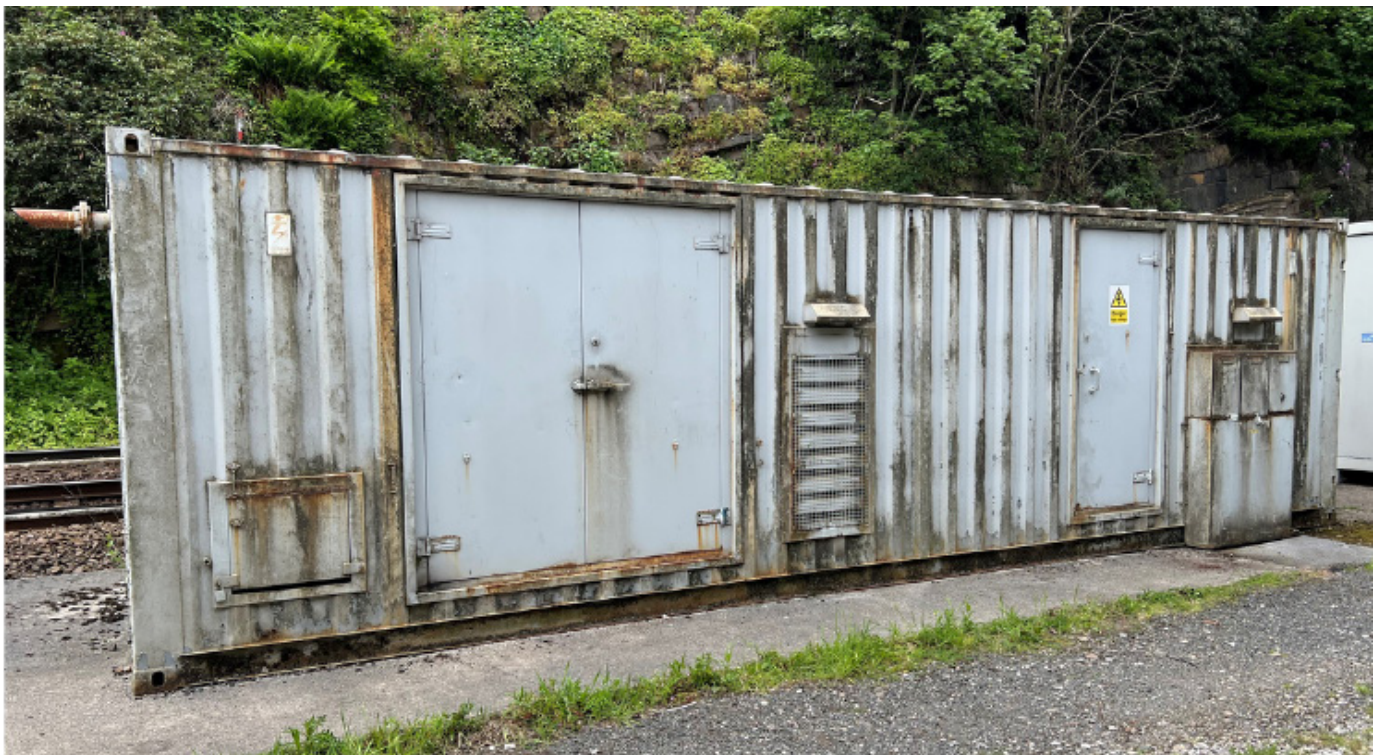
Suffering from exposure to the elements, there are visible signs of corrosion to the roofs, the walls, and the doors of these structures, resulting in water ingress into these buildings.

- **Live electrical infrastructure**
- **Exposed corroded sections**
- **Water ingress**
- **Failing ventilation systems**

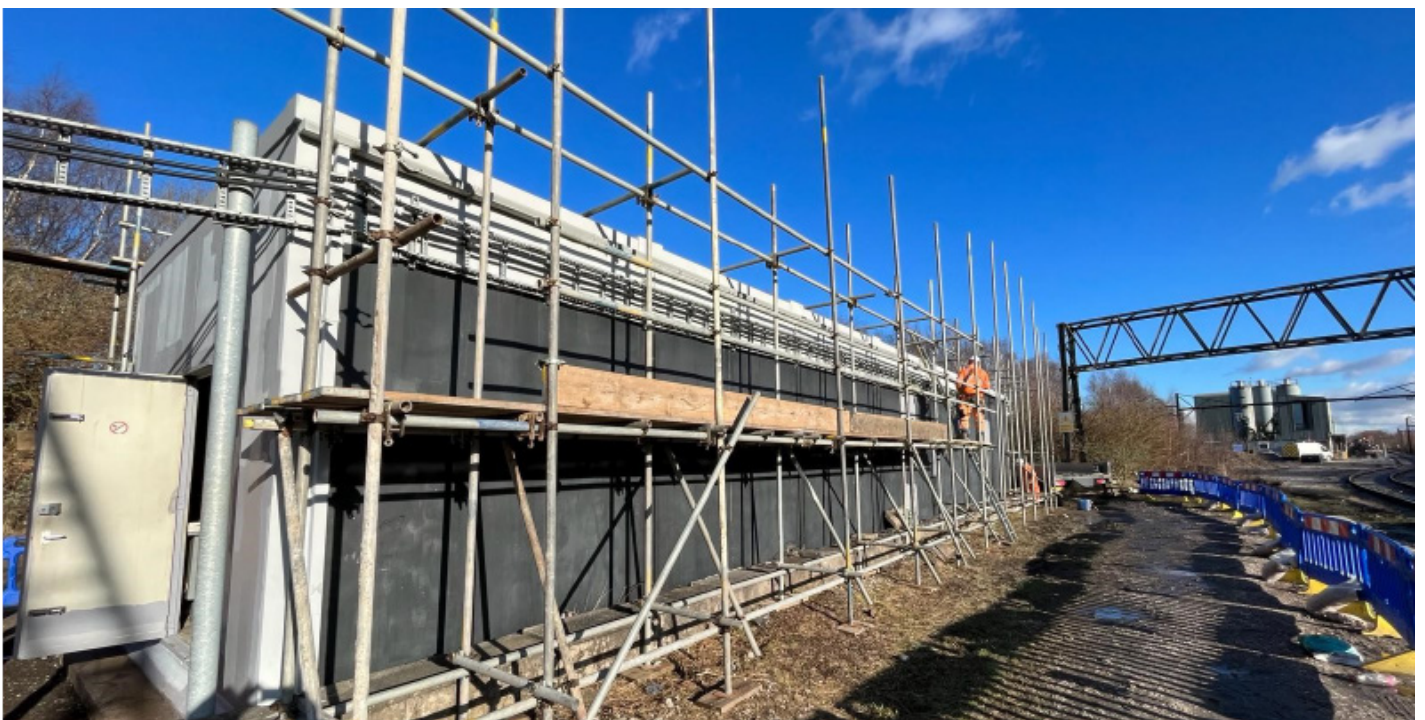
Through the use of graphene within the paint system, it creates a chemical bond with the surface material preventing moisture from getting between the paint and the surface and forming rust. This feature also allows for graffiti to easily be removed.

In most instances we identified areas of severe corrosion to the buildings which had allowed water and vermin into the structures. The ventilation systems had failed, and due to the remote locations of some buildings, vegetation had begun to reclaim the area and return it to a wild habitat.

We worked to clear the vegetation and repair the ventilation systems to keep the container interiors warm and dry. For the outer shells which had corroded beyond repair, these sections were surface prepped to St2 and treated with rust inhibitor and primed in preparation for new steel sections. We fabricated the new sections off site, which were formed to suit the existing trapizodial profiles of the buildings and fixed them with rivets. In some instances the container doors had seized and were no longer usable. These were cut out, removed from site and replaced with new. Once the structures were again strong and sound, we turned our attention to extending the life of the containers by preventing further corrosion through the use of the Therma-Light paint coating system.

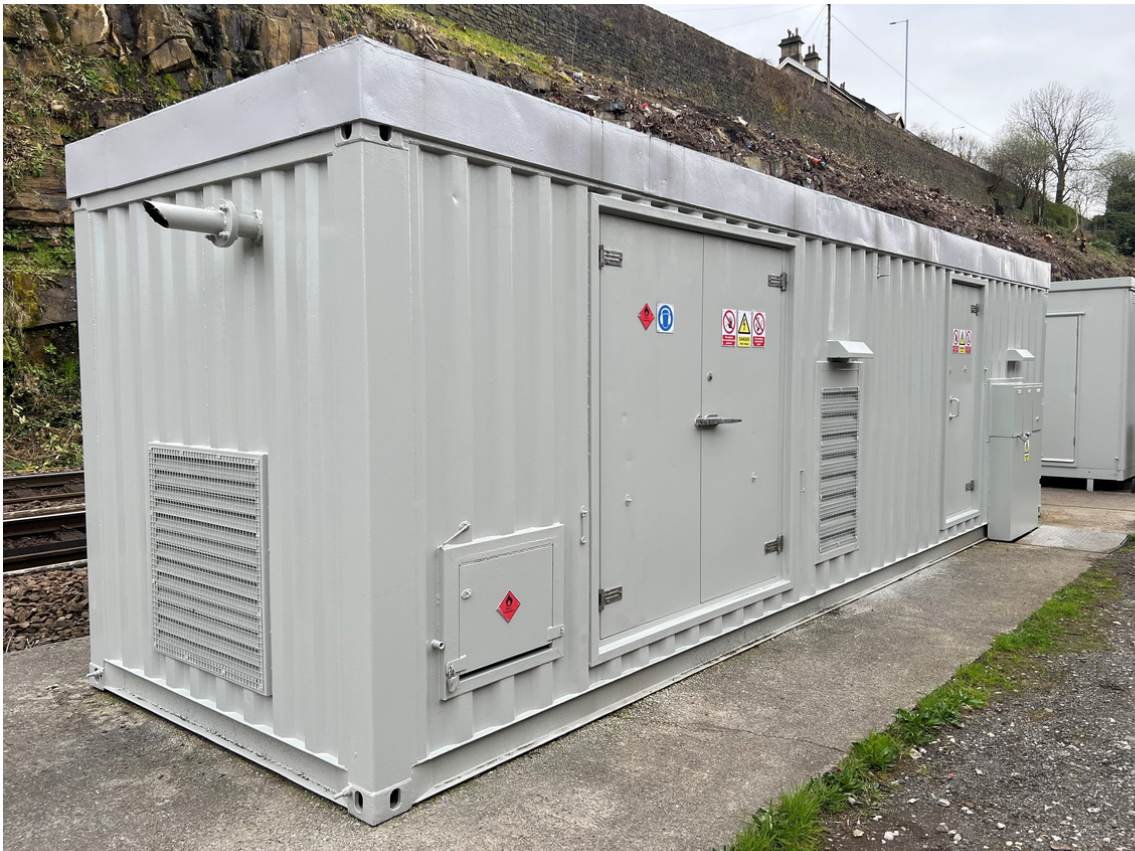
Once finished the containers looked like new. The finishing touches of new signs and labels, working ventilation systems, and the health hazards from vermin droppings and leaking roofs removed, they were now safe to be accessible to Network Rails maintenance & signalling teams.
